# **The Road Inventory of Hanalei National Wildlife Refuge Kilauea, HI**

Prepared By:  
Federal Highway Administration  
Central Federal Lands Highway Division  
April 2013

# Hanalei National Wildlife Refuge - 12522

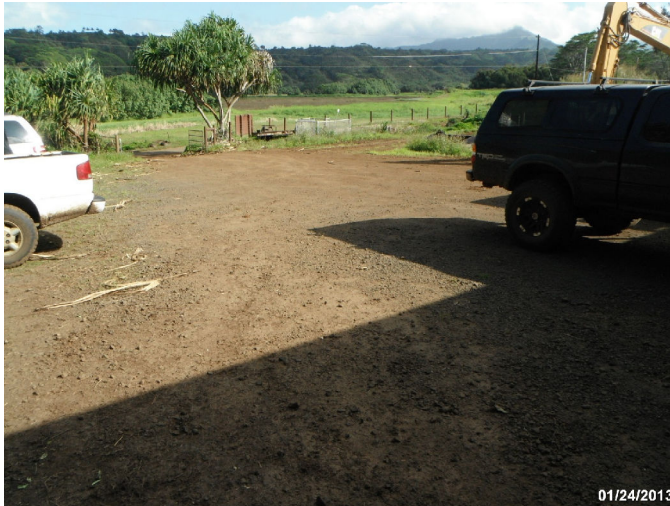
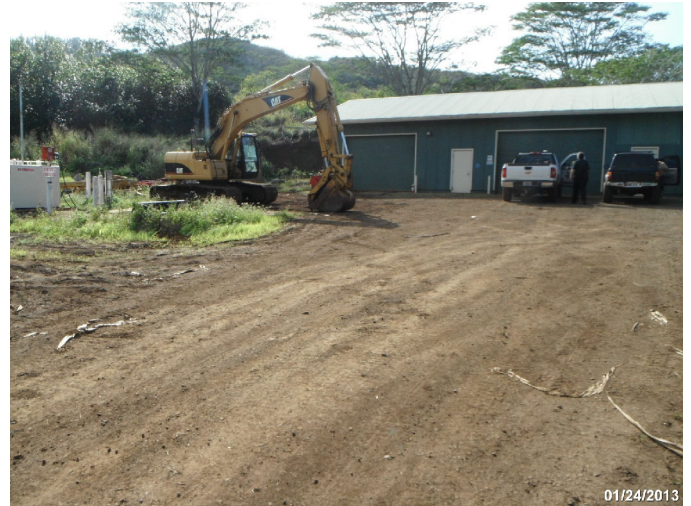
**Route Number: 801**  
**Maintenance Shop Parking**  
**From Ohiki Road**

Asset Number	Area (Sq Ft)	Spaces	Condition	Surface Type	Cost to Improve	Inspection Date	Current Replacement Value
-	8666	14	Good	Gravel	\$1,800	01-24-2013	\$58,800

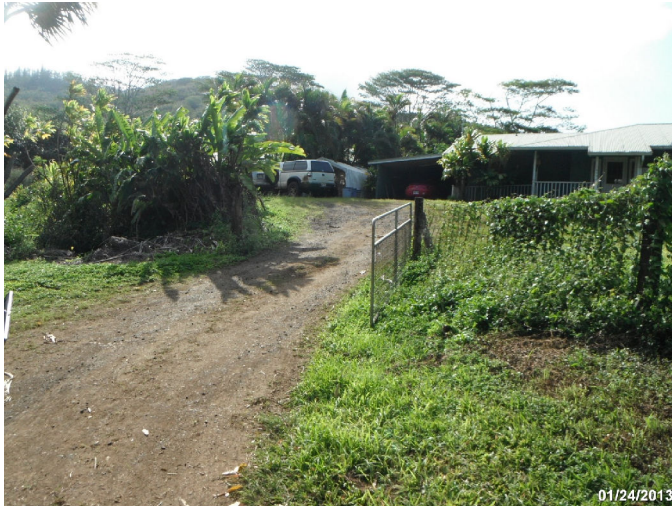
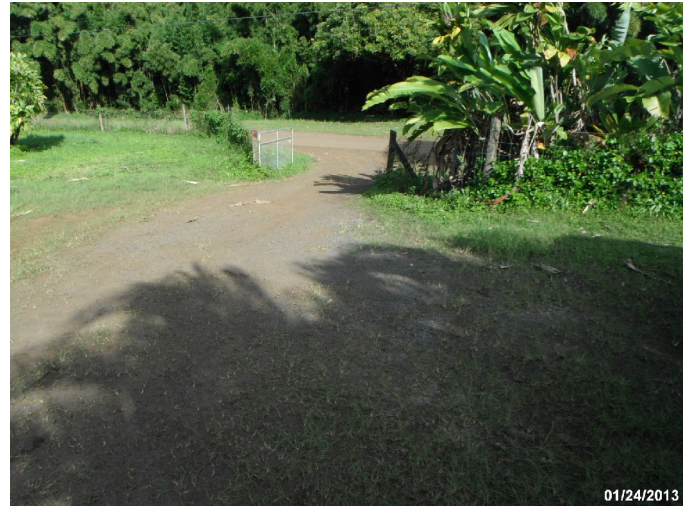
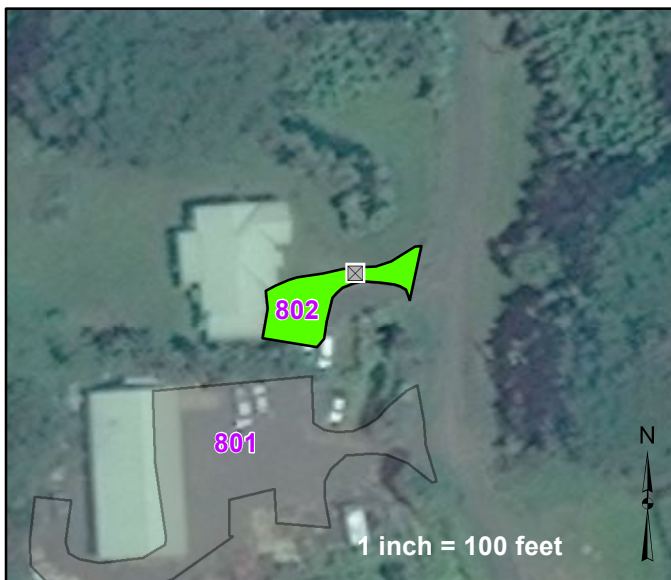
## Route Number: 802

Asset Number	Area (Sq Ft)	Spaces	Condition	Surface Type	Cost to Improve	Inspection Date	Current Replacement Value
-	1491	3	Good	Gravel	\$300	01-24-2013	\$10,100

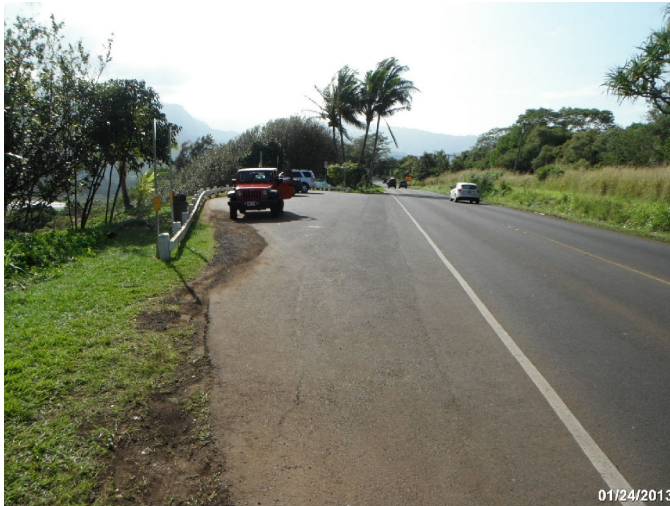
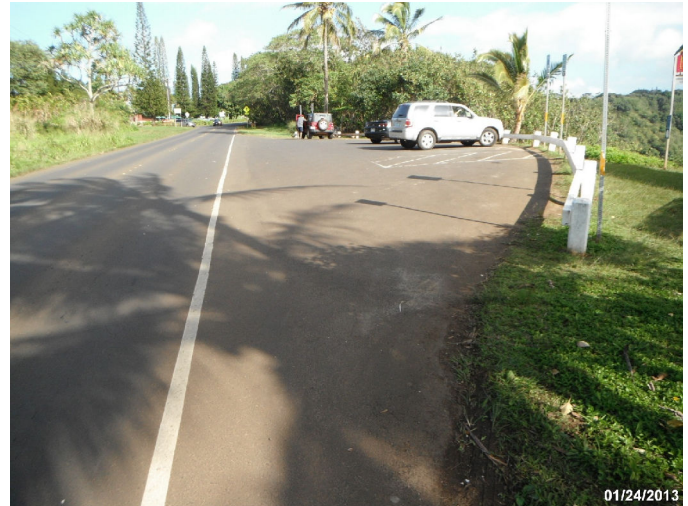
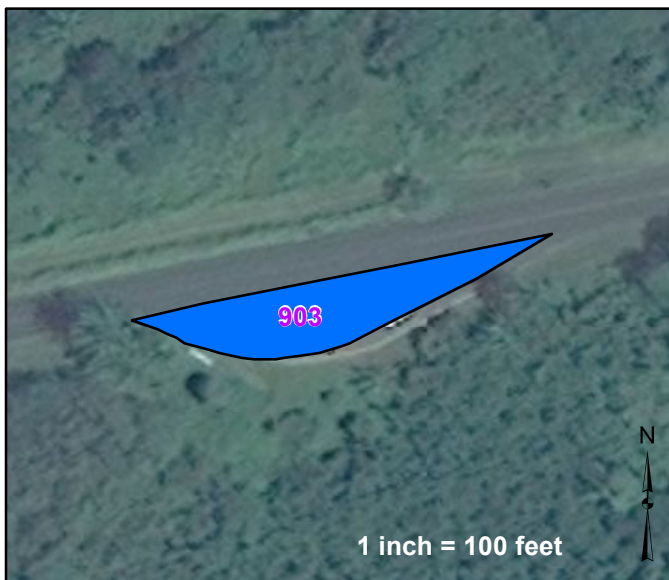
**Route Number: 903**  
**Hanalei Overlook Parking**  
 From Kuhio Highway

Asset Number	Area (Sq Ft)	Spaces	Condition	Surface Type	Cost to Improve	Inspection Date	Current Replacement Value
-	4615	8	Excellent	Asphalt	\$0	01-24-2013	\$57,400

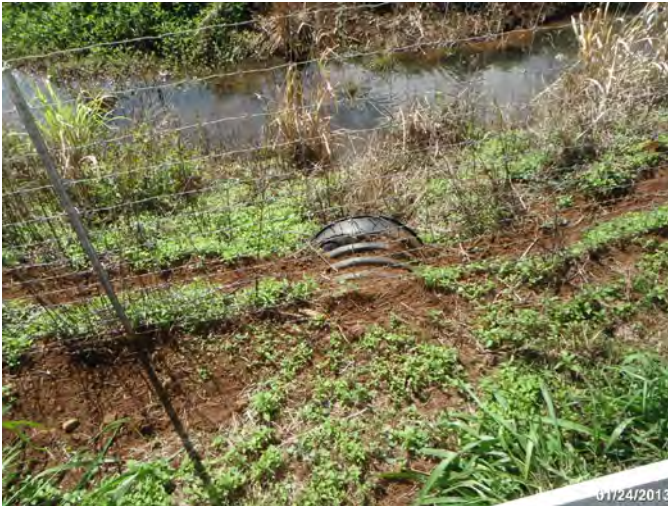
Photo: HANA\_C4\_1259 Route: 401-001-0.55  
Plastic Culvert 30ft long 24in dia. 0ft deep

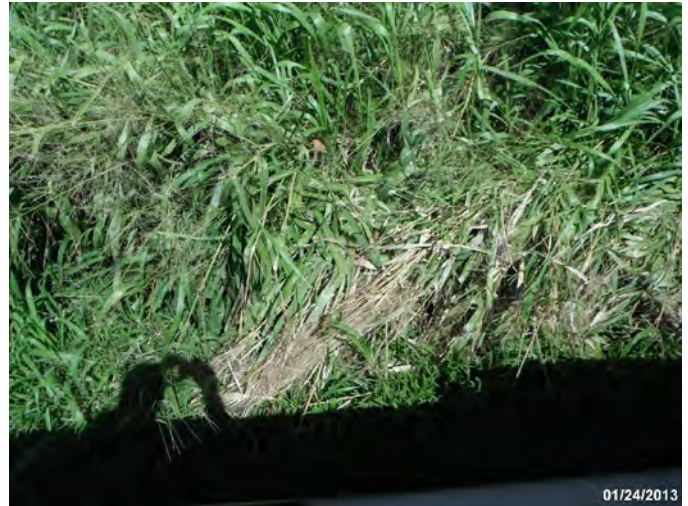
Photo: HANA\_C4\_1260 Route: 401-001-0.55  
Plastic Culvert 30ft long 24in dia. 0ft deep

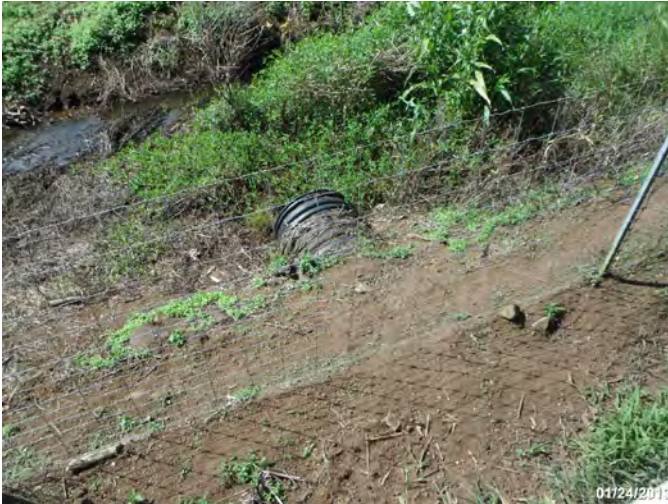
Photo: HANA\_C4\_1261 Route: 401-001-0.6  
Plastic Culvert 20ft long 24in dia. 1ft deep

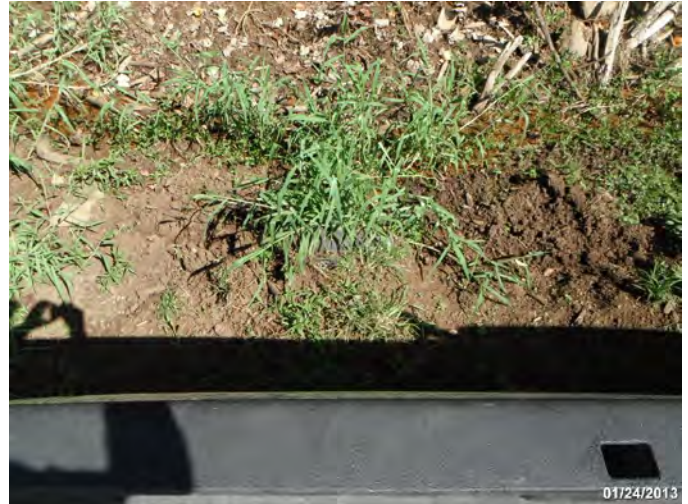
Photo: HANA\_C4\_1262 Route: 401-001-0.6  
Plastic Culvert 20ft long 24in dia. 1ft deep

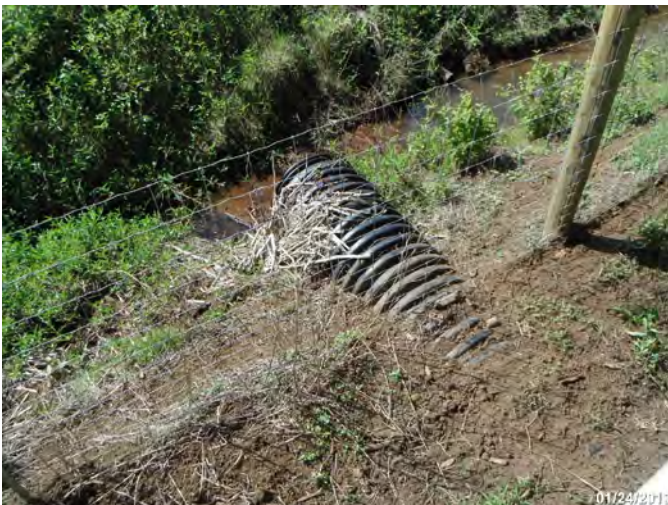
Photo: HANA\_C4\_1263 Route: 401-001-0.79  
Plastic Culvert 20ft long 24in dia. 0ft deep

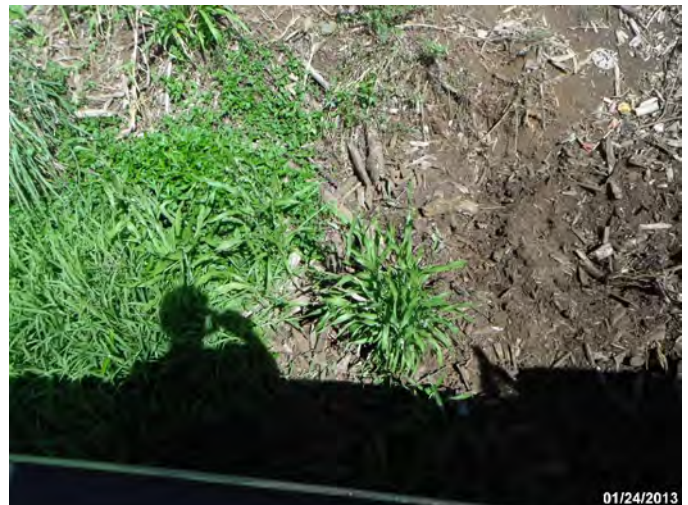
Photo: HANA\_C4\_1264 Route: 401-001-0.79  
Plastic Culvert 20ft long 24in dia. 0ft deep

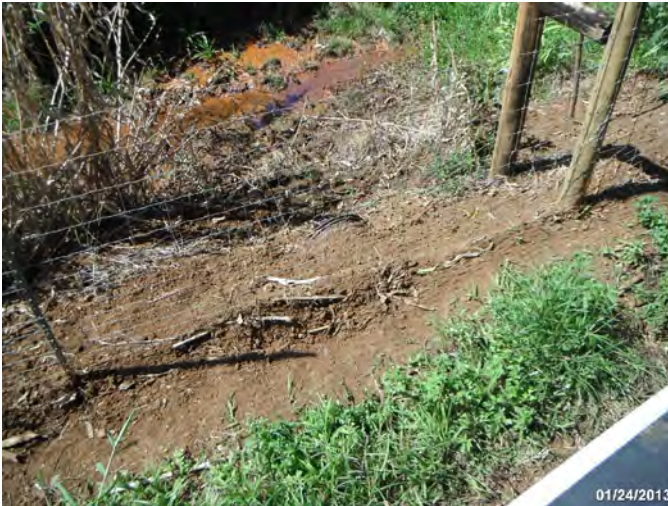
Photo: HANA\_C4\_1265 Route: 401-001-0.83  
Plastic Culvert 20ft long 24in dia. 1ft deep

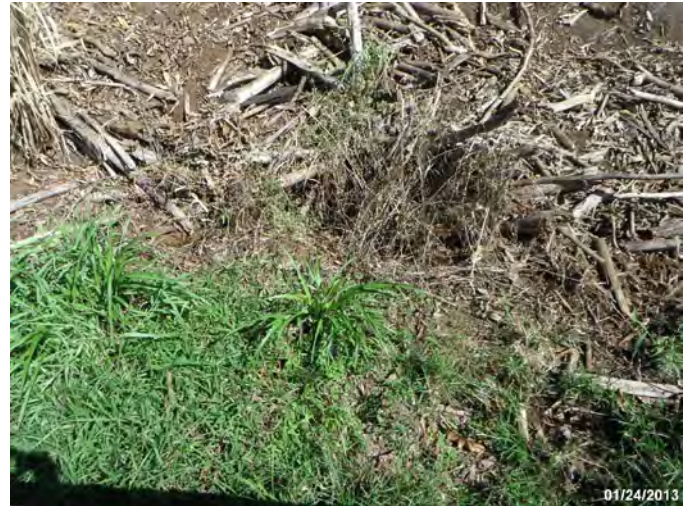
Photo: HANA\_C4\_1266 Route: 401-001-0.83  
Plastic Culvert 20ft long 24in dia. 1ft deep

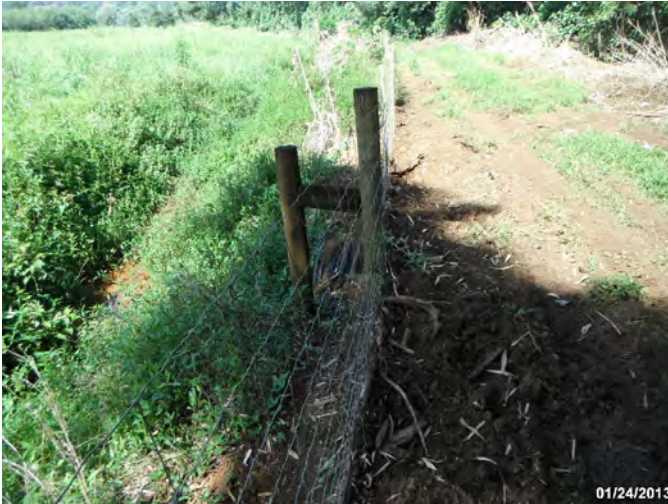
Photo: HANA\_C4\_1268 Route: 401-001-0.85  
Plastic Culvert 20ft long 24in dia. 1ft deep

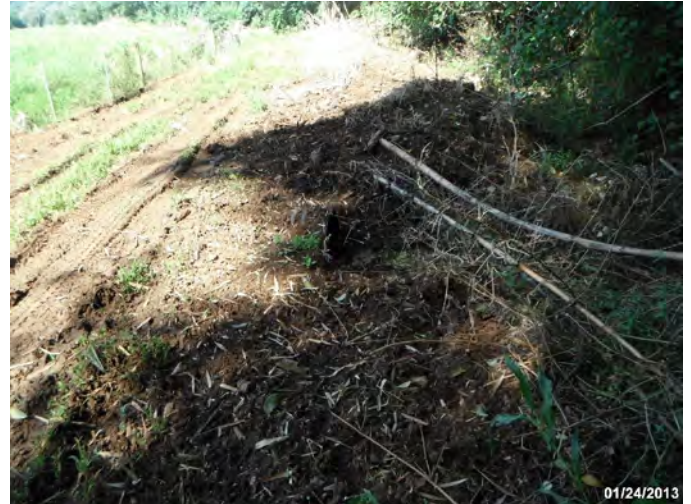
Photo: HANA\_C4\_1269 Route: 401-001-0.85  
Plastic Culvert 20ft long 24in dia. 1ft deep

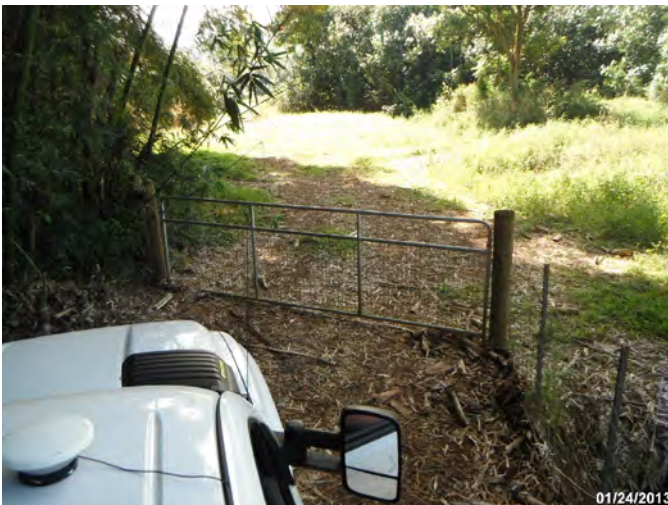
Photo: HANA\_C4\_1267 Route: 401-001-0.85  
Metal Open Rail Gate

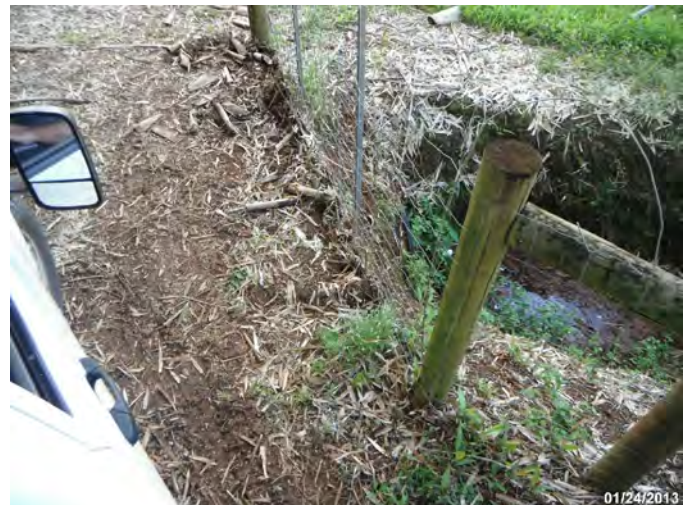
Photo: HANA\_C4\_1270 Route: 401-001-0.86  
Plastic Culvert 20ft long 24in dia. 1ft deep

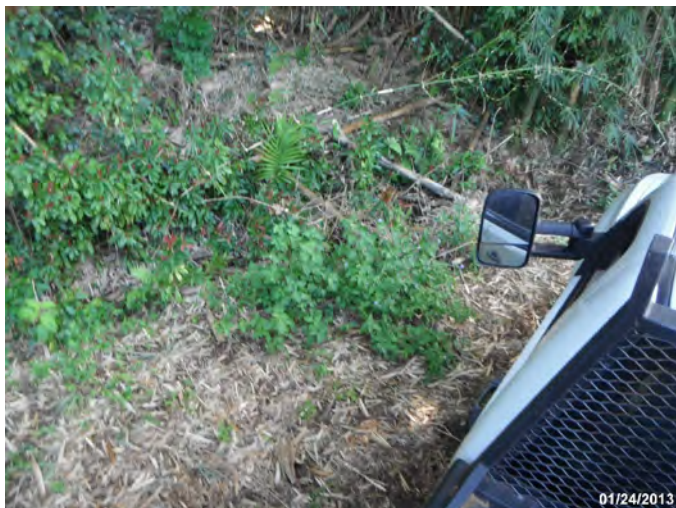
Photo: HANA\_C4\_1271 Route: 401-001-0.86  
Plastic Culvert 20ft long 24in dia. 1ft deep

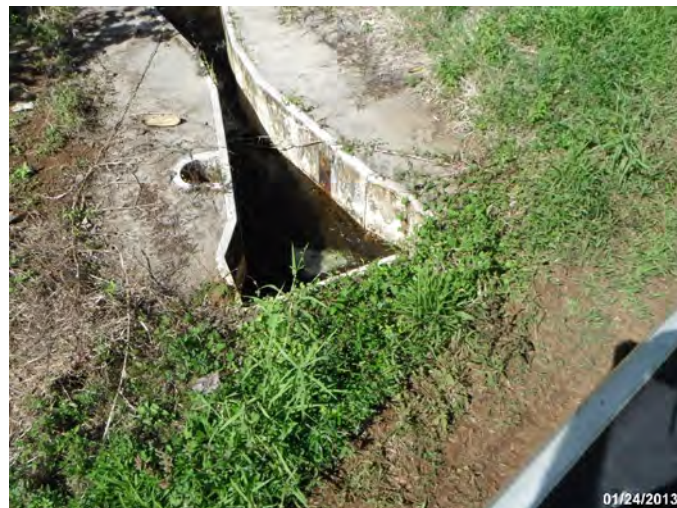
Photo: HANA\_C4\_1272 Route: 401-001-0.88  
Plastic WCS Other 30ft long 18in dia. 1ft deep

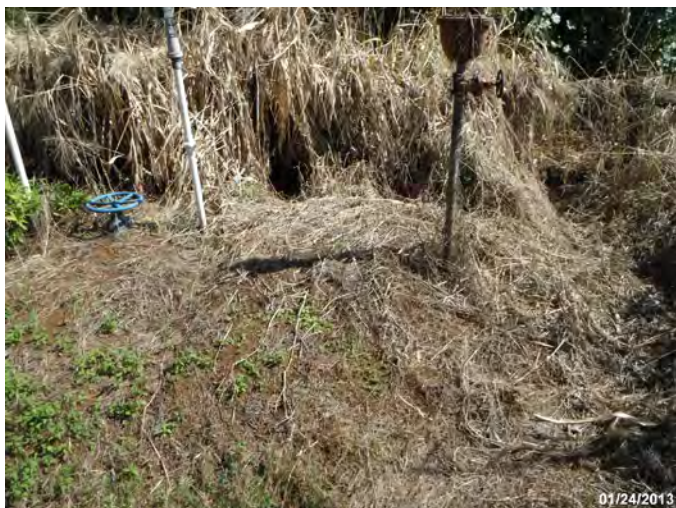
Photo: HANA\_C4\_1273 Route: 401-001-0.88  
Plastic WCS Other 30ft long 18in dia. 1ft deep

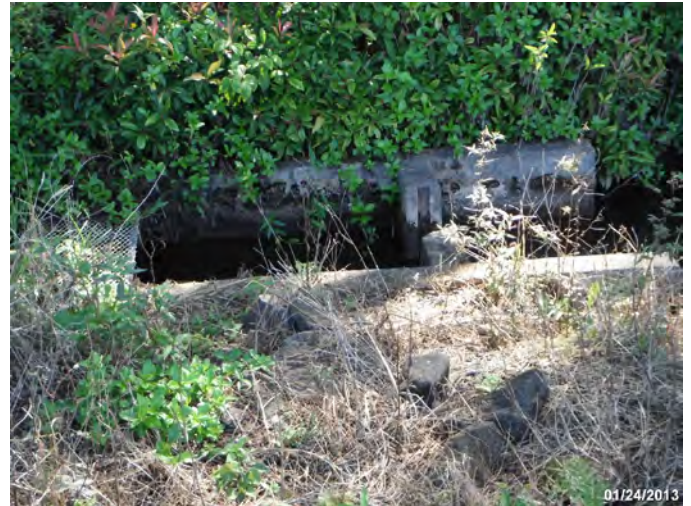
Photo: HANA\_C4\_1283 Route: 402-001-0.0  
Plastic WCS Screw Gate 900ft long 12in dia. 2ft deep

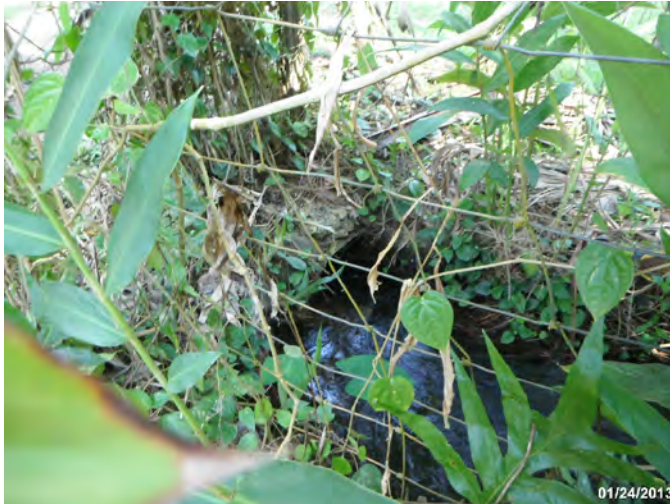
Photo: HANA\_C4\_1276 Route: 402-001-0.02  
Metal Culvert 20ft long 18in dia. 1ft deep

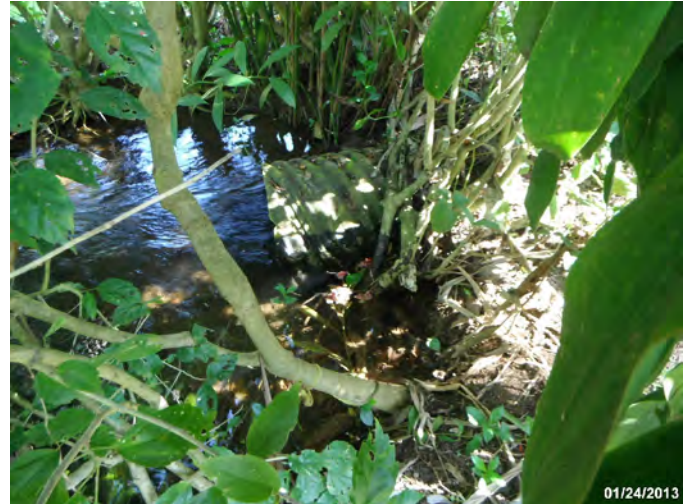
Photo: HANA\_C4\_1277 Route: 402-001-0.02  
Metal Culvert 20ft long 18in dia. 1ft deep

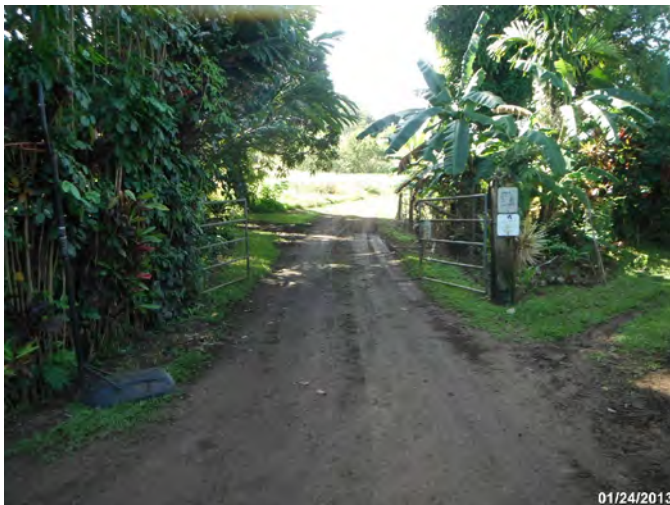
Photo: HANA\_C4\_1278 Route: 402-001-0.02  
Metal Open Rail Gate

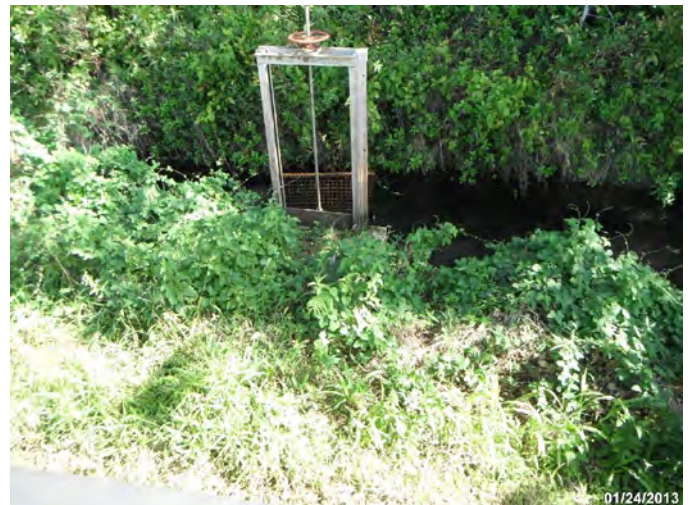
Photo: HANA\_C4\_1281 Route: 402-001-0.3  
Plastic WCS Screw Gate 80ft long 24in dia. 1ft deep  
8-009

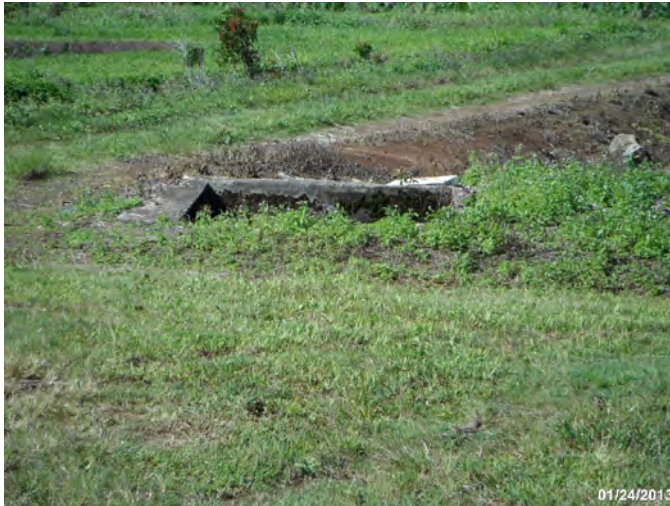
Photo: HANA\_C4\_1282 Route: 402-001-0.3  
Plastic WCS Screw Gate 80ft long 24in dia. 1ft deep

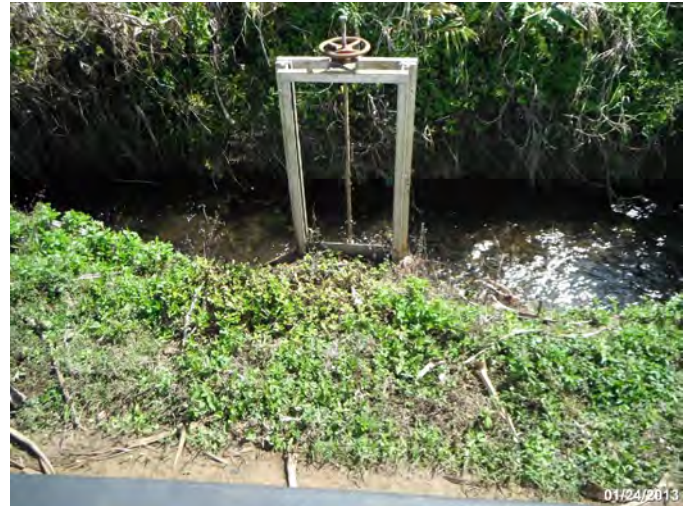
Photo: HANA\_C4\_1279 Route: 402-001-0.92  
Plastic WCS Screw Gate 40ft long 24in dia. 2ft deep

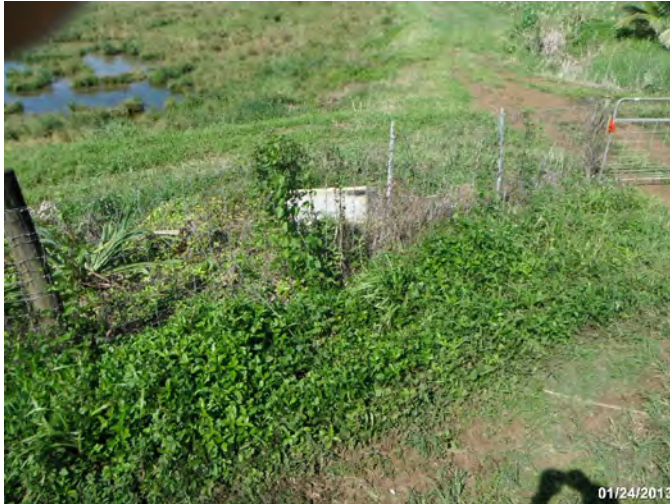
Photo: HANA\_C4\_1280 Route: 402-001-0.92  
Plastic WCS Screw Gate 40ft long 24in dia. 2ft deep

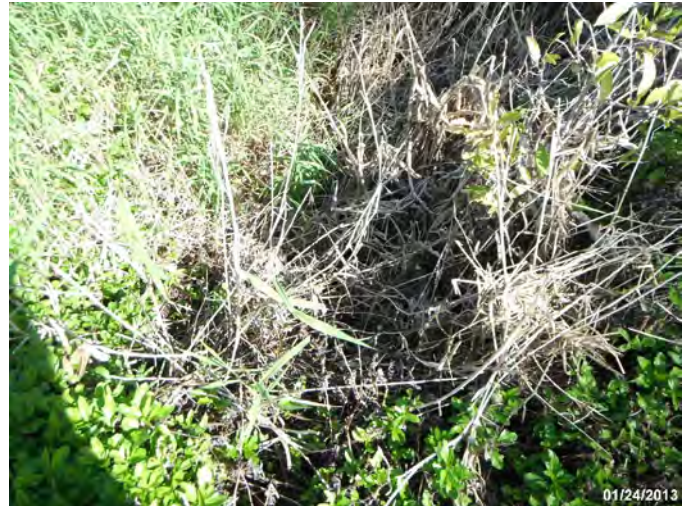
Photo: HANA\_C4\_1287 Route: 403-001-0.01  
Metal Culvert 20ft long 24in dia. 1ft deep

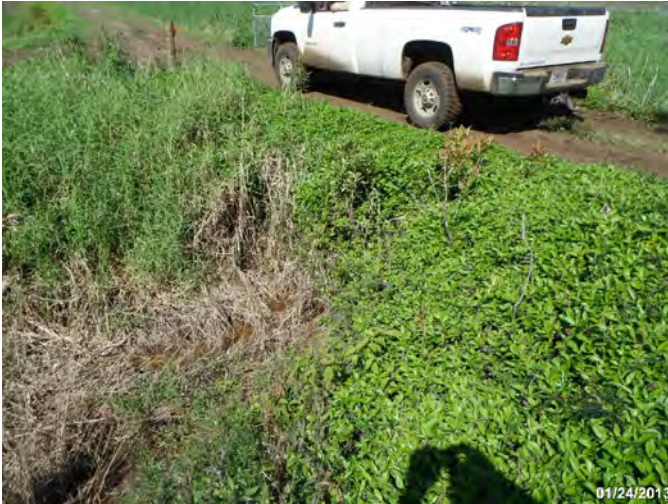
Photo: HANA\_C4\_1288 Route: 403-001-0.01  
Metal Culvert 20ft long 24in dia. 1ft deep

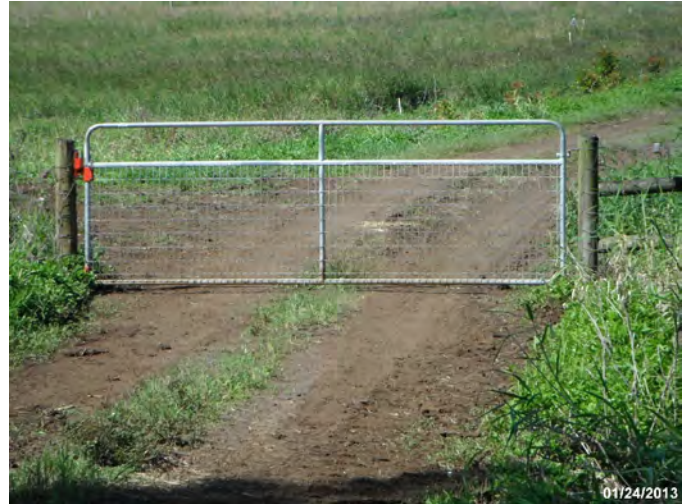
Photo: HANA\_C4\_1286 Route: 403-001-0.01  
Metal Open Rail Gate

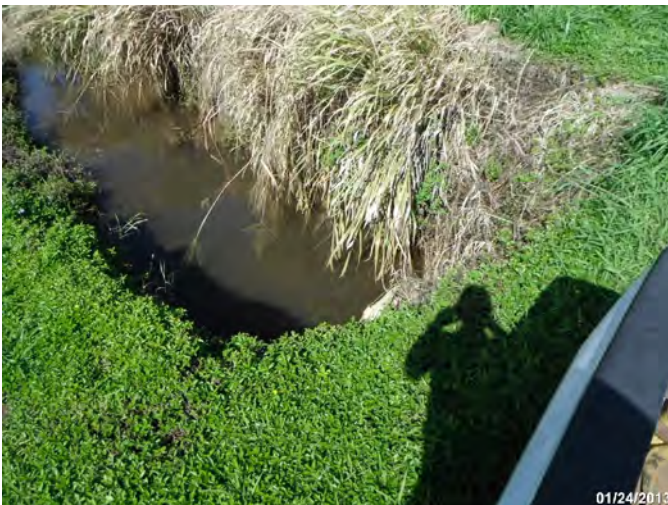
Photo: HANA\_C4\_1289 Route: 403-001-0.57  
Metal Culvert 15ft long 36in dia. 2ft deep

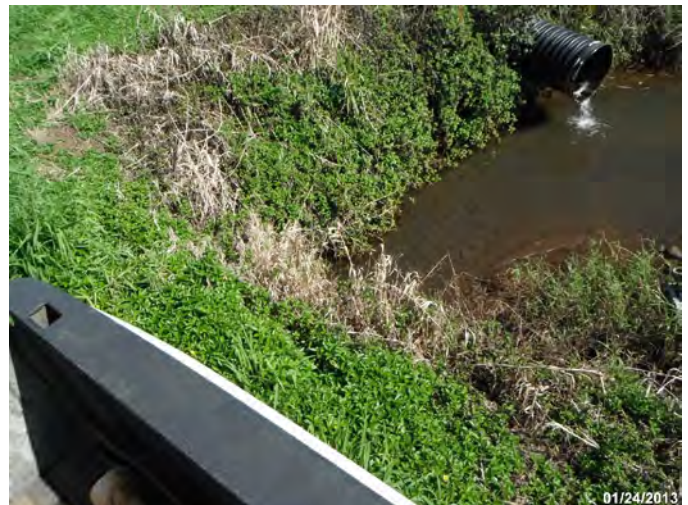
Photo: HANA\_C4\_1290 Route: 403-001-0.57  
Metal Culvert 15ft long 36in dia. 2ft deep

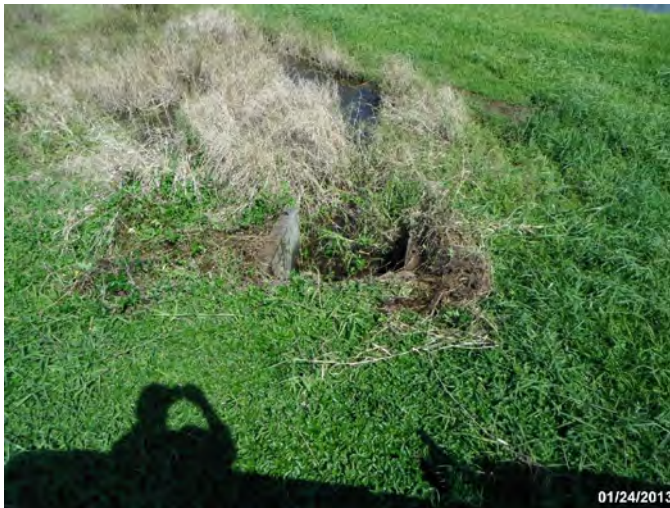
Photo: HANA\_C4\_1291 Route: 403-001-0.8  
Metal WCS Flashboard Riser 60ft long 24in dia. 2ft deep

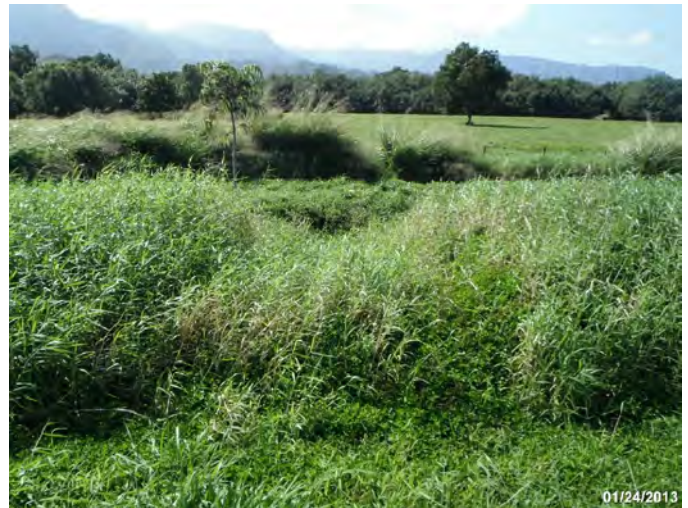
Photo: HANA\_C4\_1292 Route: 403-001-0.8  
Metal WCS Flashboard Riser 60ft long 24in dia. 2ft deep

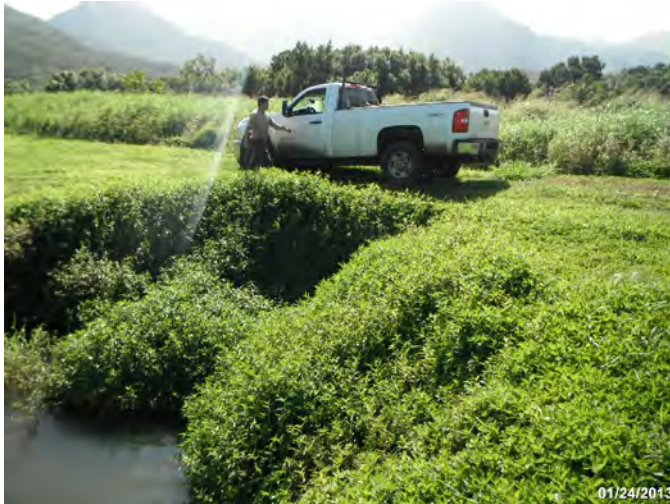
Photo: HANA\_C4\_1293 Route: 403-001-0.83  
Metal Culvert 40ft long 36in dia. 4ft deep

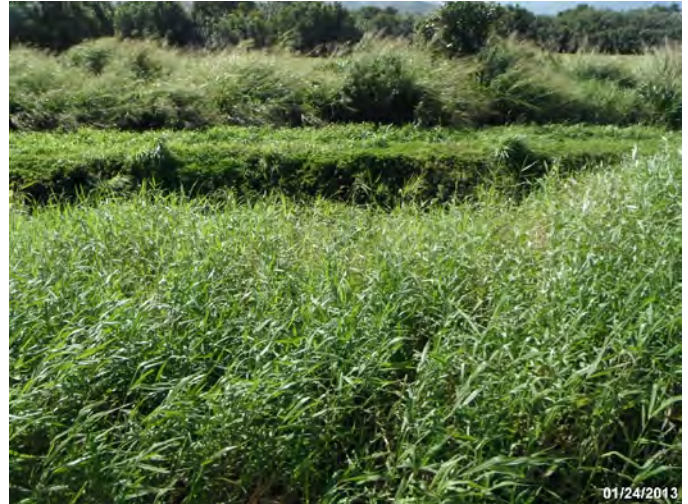
Photo: HANA\_C4\_1294 Route: 403-001-0.83  
Metal Culvert 40ft long 36in dia. 4ft deep

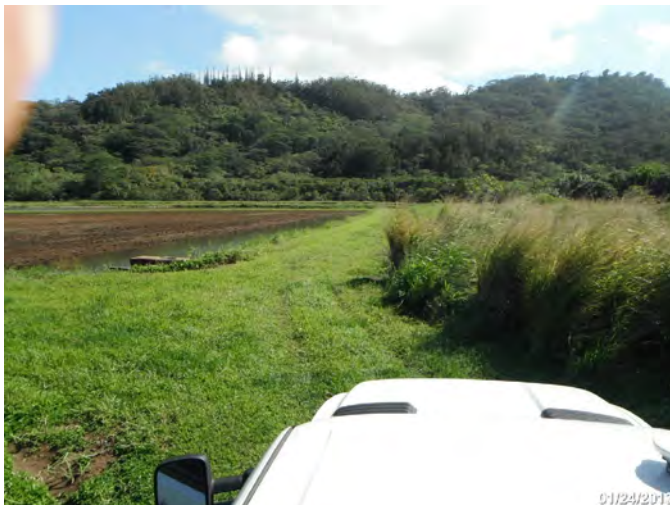
Photo: HANA\_C4\_1295 Route: 403-001-0.94  
Metal Culvert 40ft long 24in dia. 4ft deep

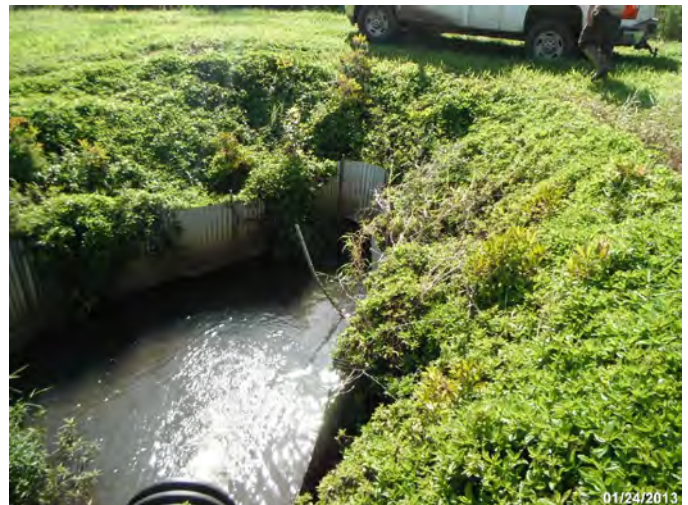
Photo: HANA\_C4\_1296 Route: 403-001-0.94  
Metal Culvert 40ft long 24in dia. 4ft deep

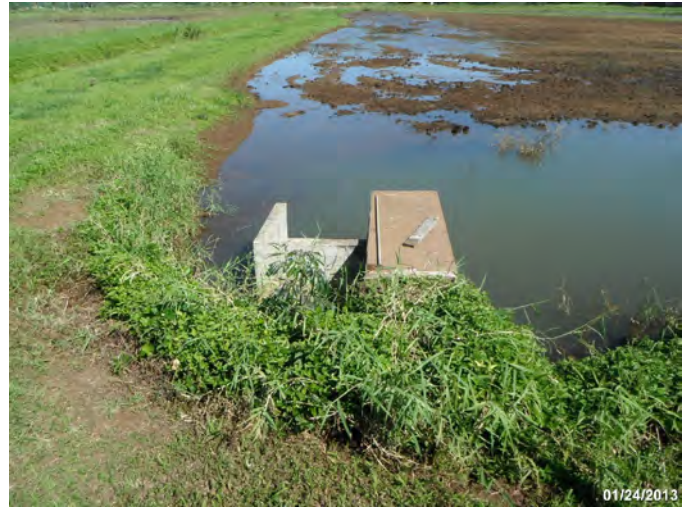
Photo: HANA\_C4\_1298 Route: 403-002-0.95  
Plastic WCS Flashboard Riser 60ft long 24in dia. 3ft deep

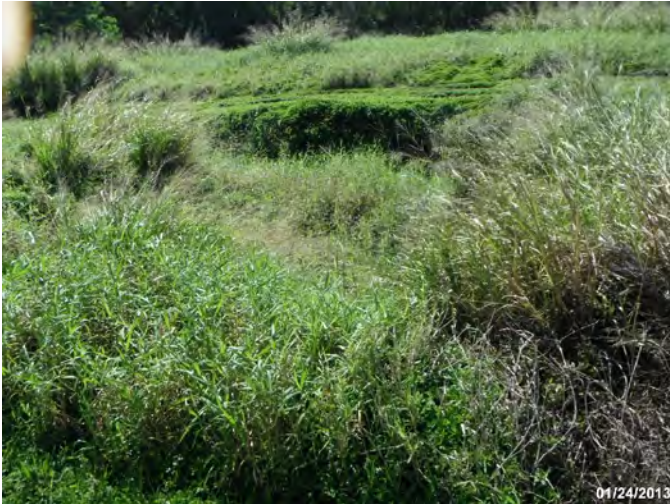
Photo: HANA\_C4\_1299 Route: 403-002-0.95  
Plastic WCS Flashboard Riser 60ft long 24in dia. 3ft deep

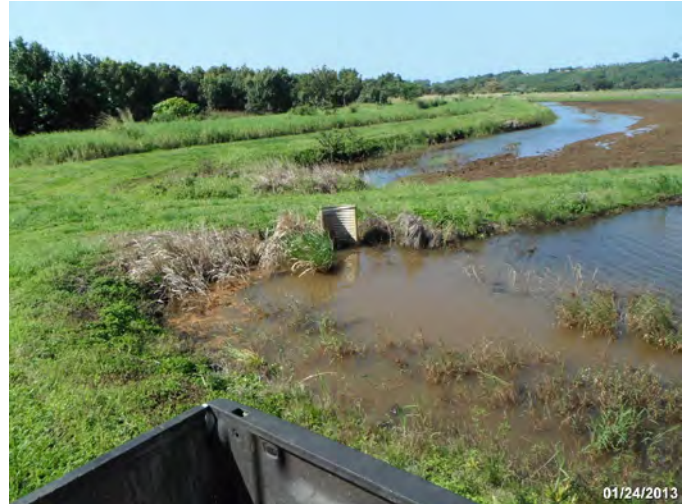
Photo: HANA\_C4\_1300 Route: 403-002-1.06  
Plastic WCS Flashboard Riser 120ft long 24in dia. 2ft deep

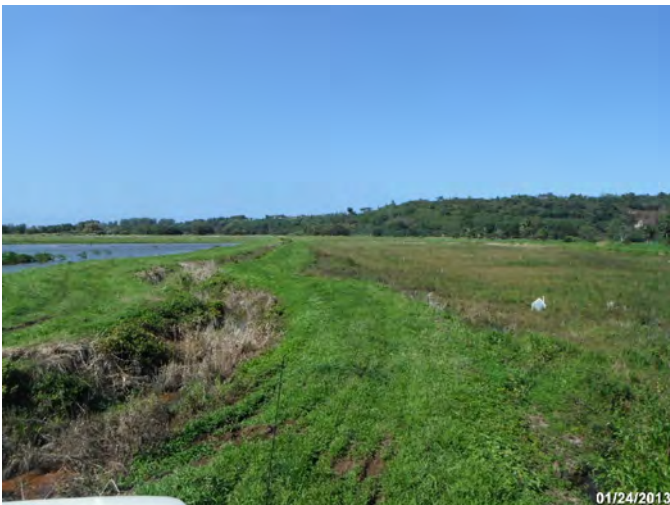
Photo: HANA\_C4\_1301 Route: 403-002-1.06  
Plastic WCS Flashboard Riser 120ft long 24in dia. 2ft deep

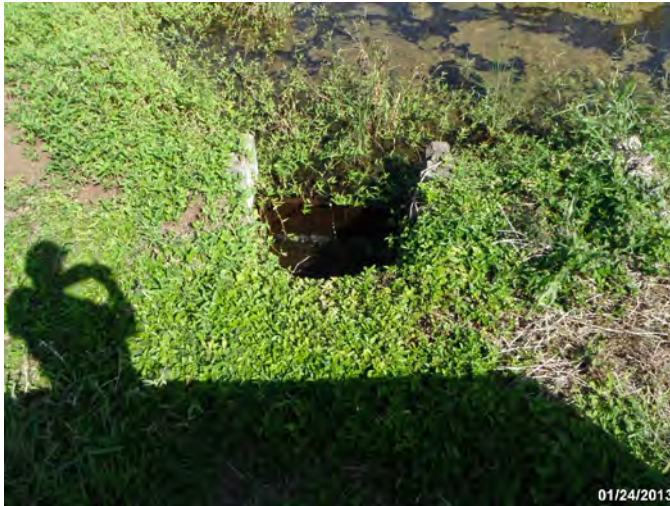
Photo: HANA\_C4\_1302 Route: 403-003-1.38  
Plastic WCS Flashboard Riser 30ft long 24in dia. 2ft deep

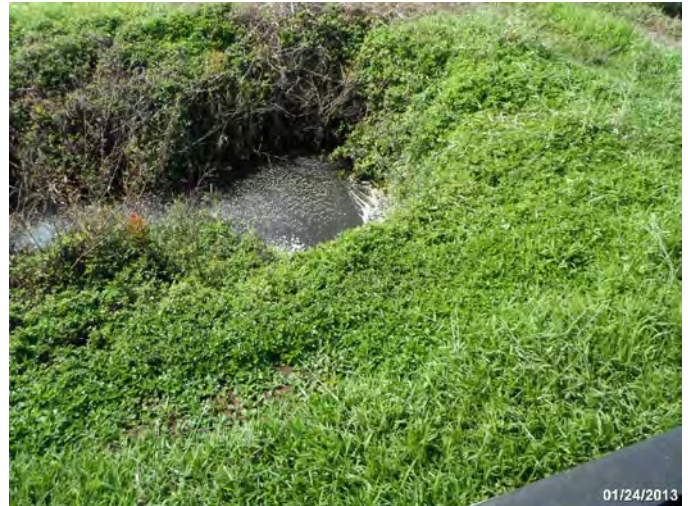
Photo: HANA\_C4\_1303 Route: 403-003-1.38  
Plastic WCS Flashboard Riser 30ft long 24in dia. 2ft deep

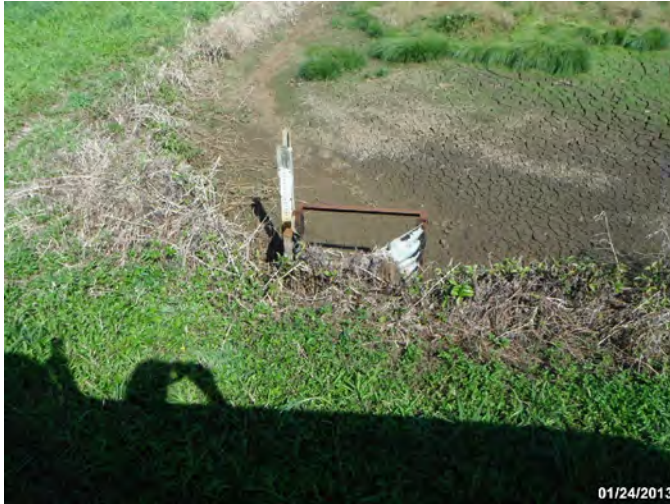
Photo: HANA\_C4\_1304 Route: 403-003-1.5  
Metal WCS Flashboard Riser 30ft long 24in dia. 3ft deep

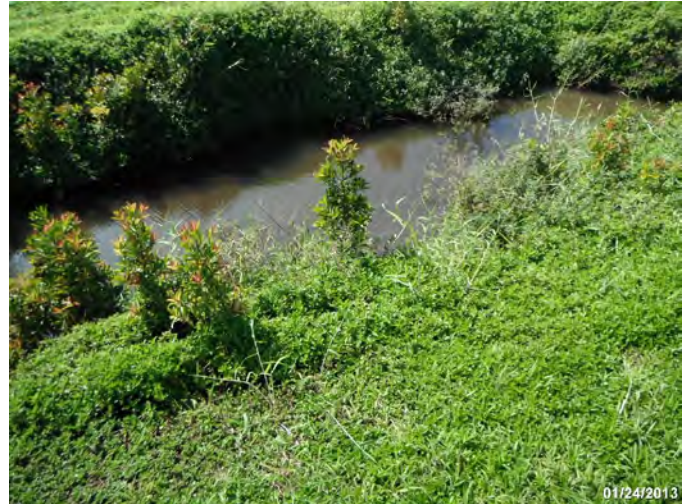
Photo: HANA\_C4\_1305 Route: 403-003-1.5  
Metal WCS Flashboard Riser 30ft long 24in dia. 3ft deep

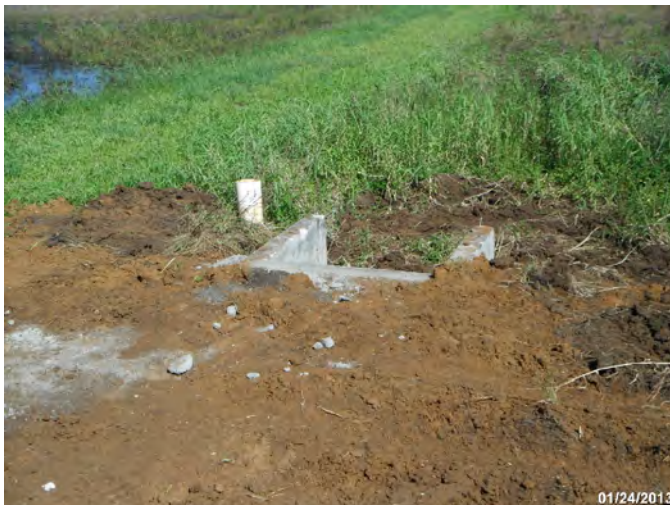
Photo: HANA\_C4\_1306 Route: 403-003-1.58  
Plastic WCS Flashboard Riser 40ft long 24in dia. 2ft deep

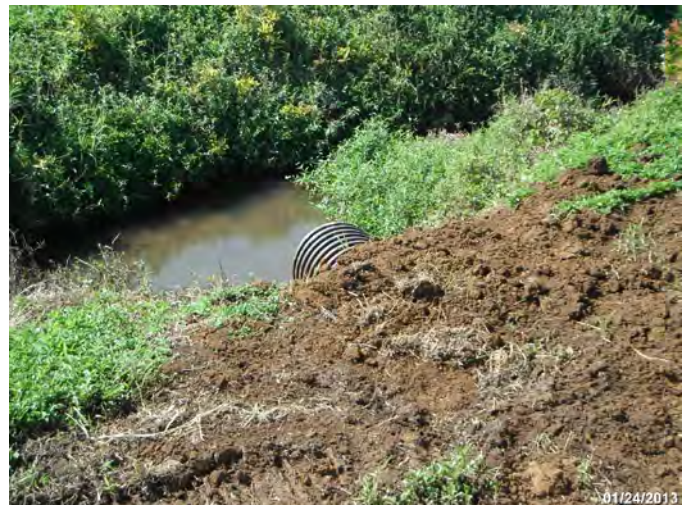
Photo: HANA\_C4\_1307 Route: 403-003-1.58  
Plastic WCS Flashboard Riser 40ft long 24in dia. 2ft deep  
8-014

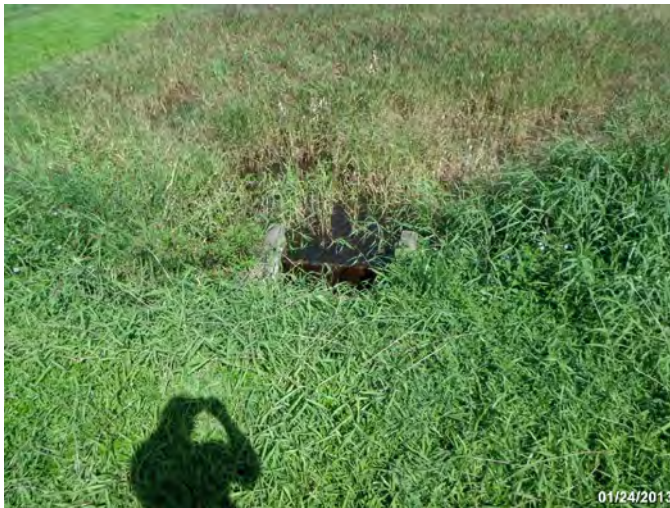
Photo: HANA\_C4\_1308 Route: 403-003-1.68  
Plastic WCS Flashboard Riser 40ft long 24in dia. 3ft deep

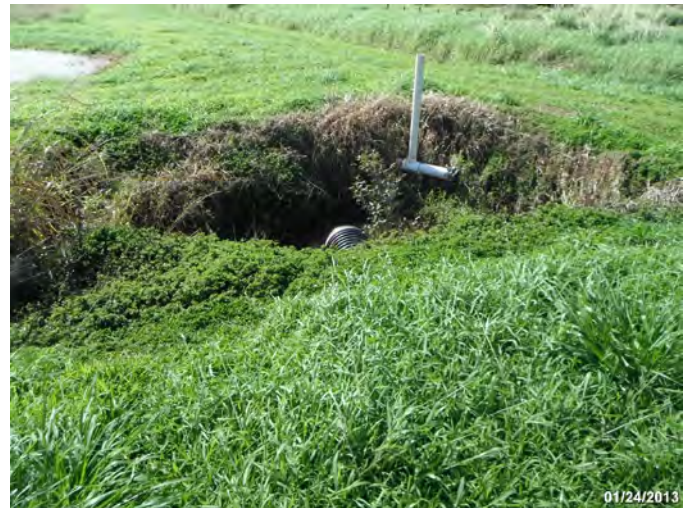
Photo: HANA\_C4\_1309 Route: 403-003-1.68  
Plastic WCS Flashboard Riser 40ft long 24in dia. 3ft deep

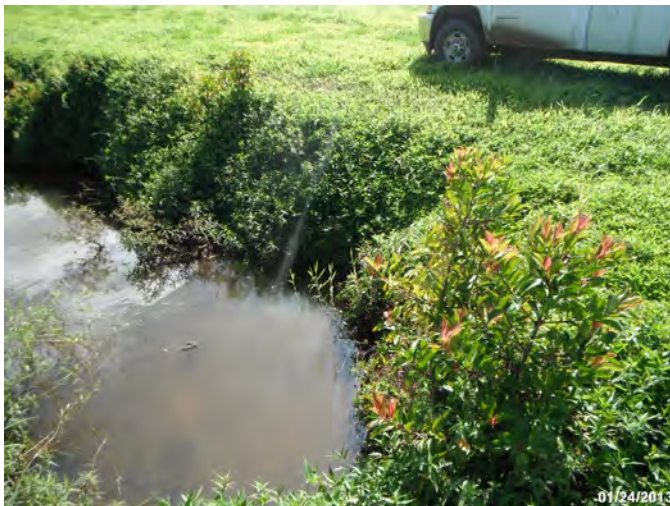
Photo: HANA\_C4\_1310 Route: 403-003-1.9  
Plastic Culvert 40ft long 24in dia. 2ft deep

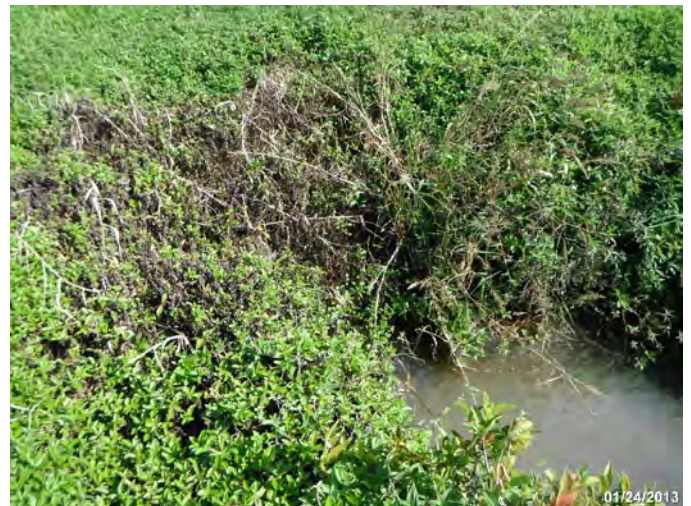
Photo: HANA\_C4\_1311 Route: 403-003-1.9  
Plastic Culvert 40ft long 24in dia. 2ft deep

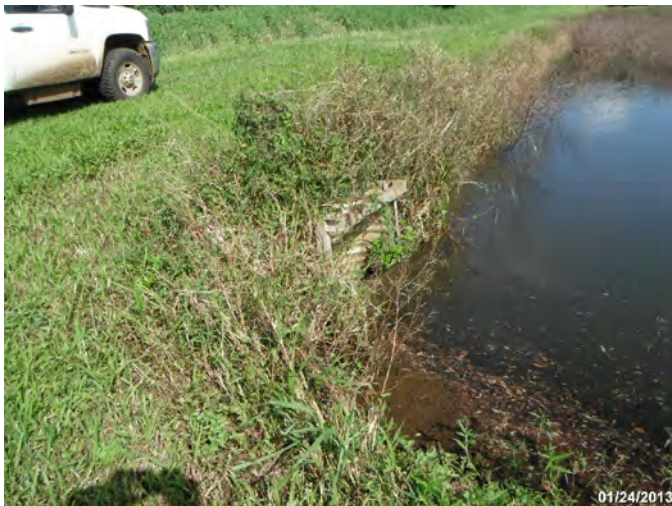
Photo: HANA\_C4\_1314 Route: 404-001-0.12  
Metal WCS Flashboard Riser 80ft long 24in dia. 3ft deep  
other end is buried in a dike

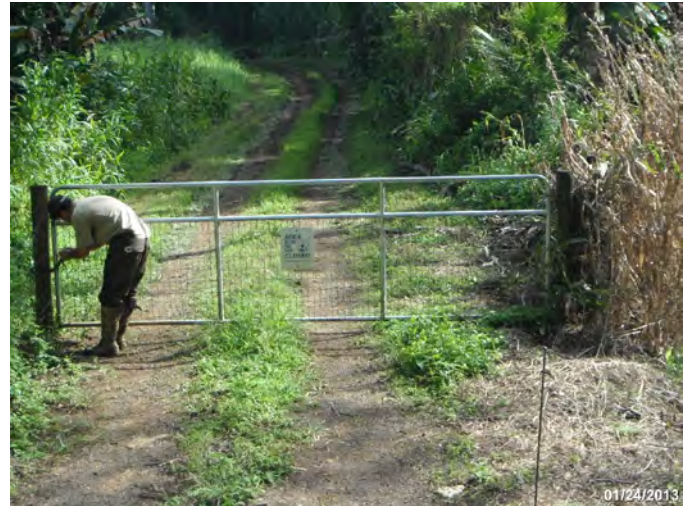
Photo: HANA\_C4\_1322 Route: 405-001-0.01  
Metal Open Rail Gate

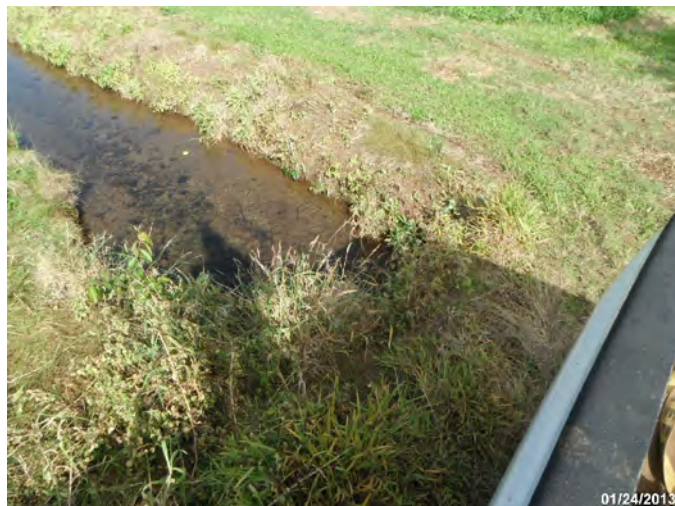
Photo: HANA\_C4\_1324 Route: 406-002-0.22  
Metal Culvert 20ft long 24in dia. 2ft deep

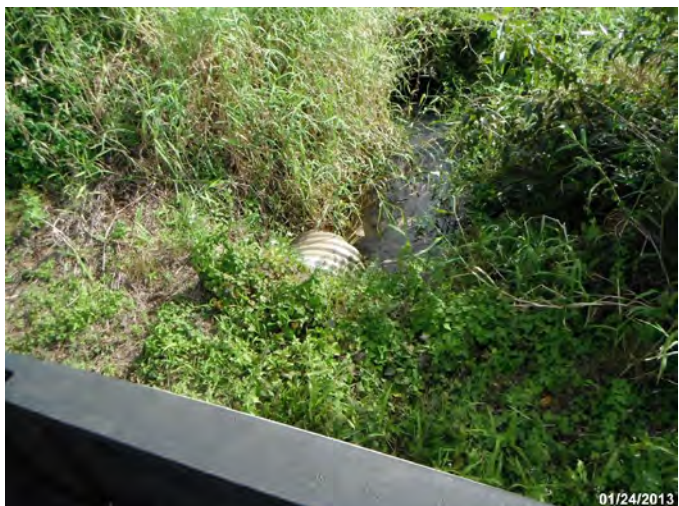
Photo: HANA\_C4\_1325 Route: 406-002-0.22  
Metal Culvert 20ft long 24in dia. 2ft deep

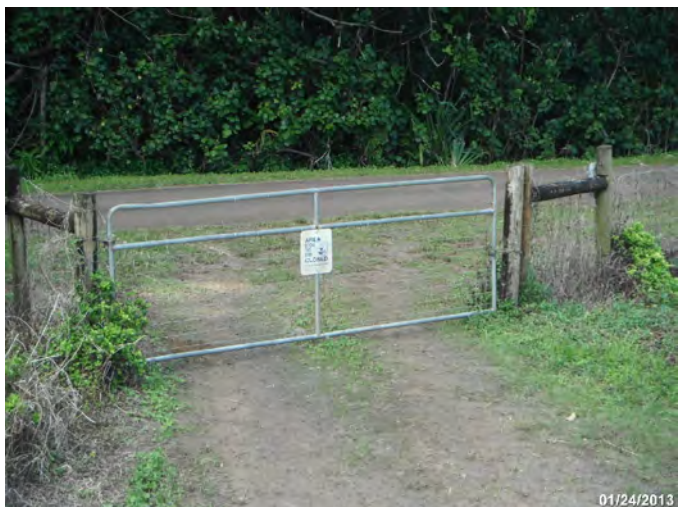
Photo: HANA\_C4\_1327 Route: 406-002-0.37  
Metal Open Rail Gate

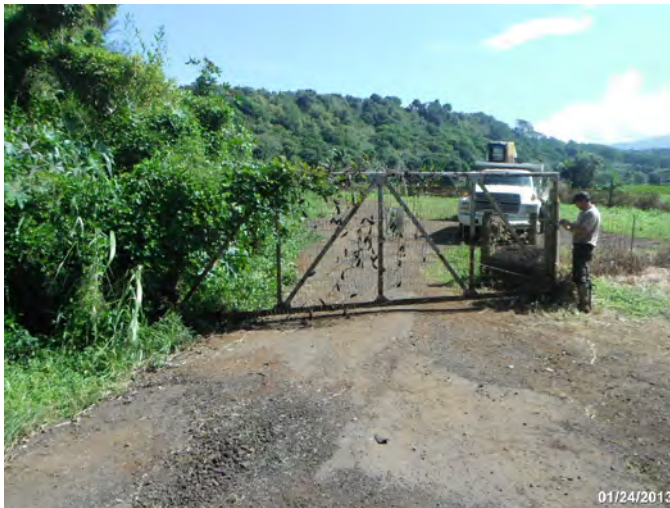
Photo: HANA\_C4\_1238 Route: 800  
Metal Open Rail Gate
